U.S. Department
of Transportation
**Urban Mass
Transportation
Administration**

Evacuation and Rescue of Elderly and Disabled Passengers from Paratransit Vans and Buses

October 1984
Final Report

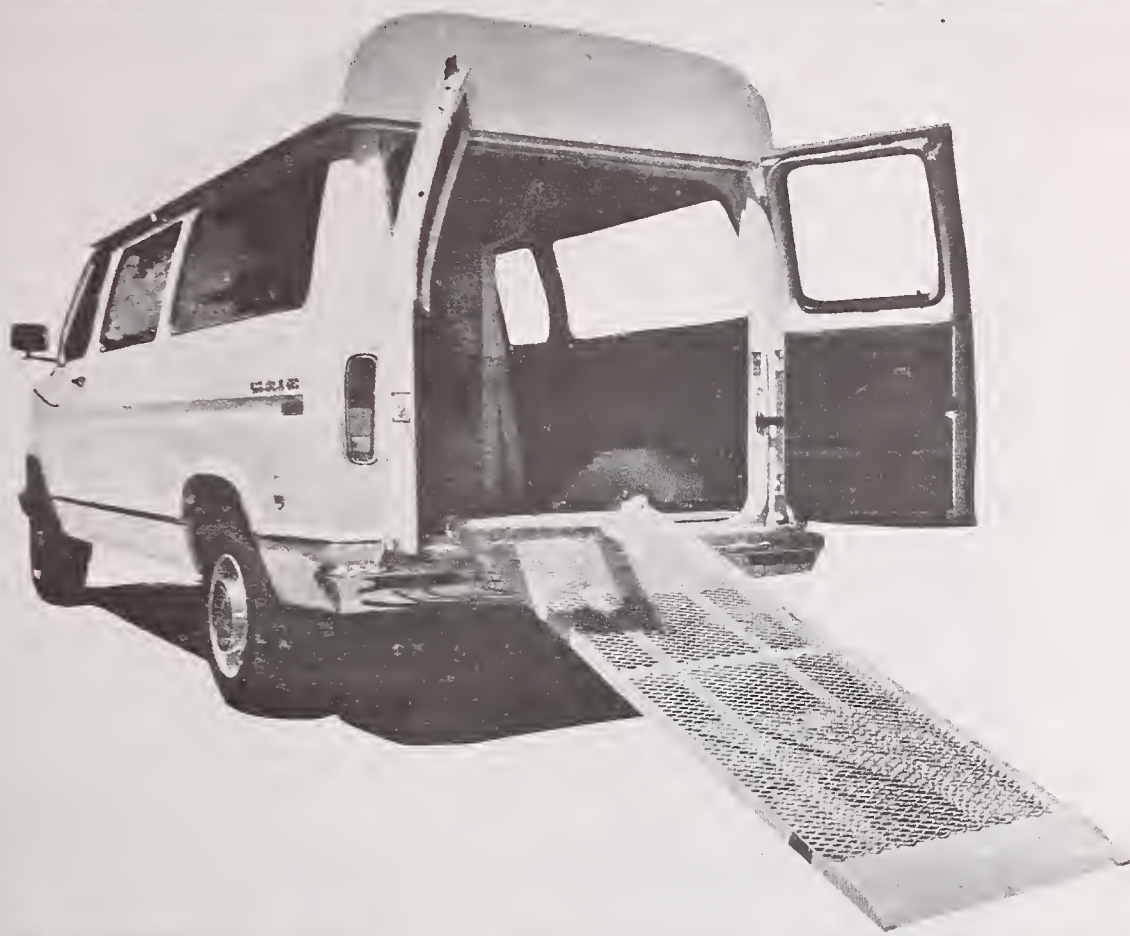
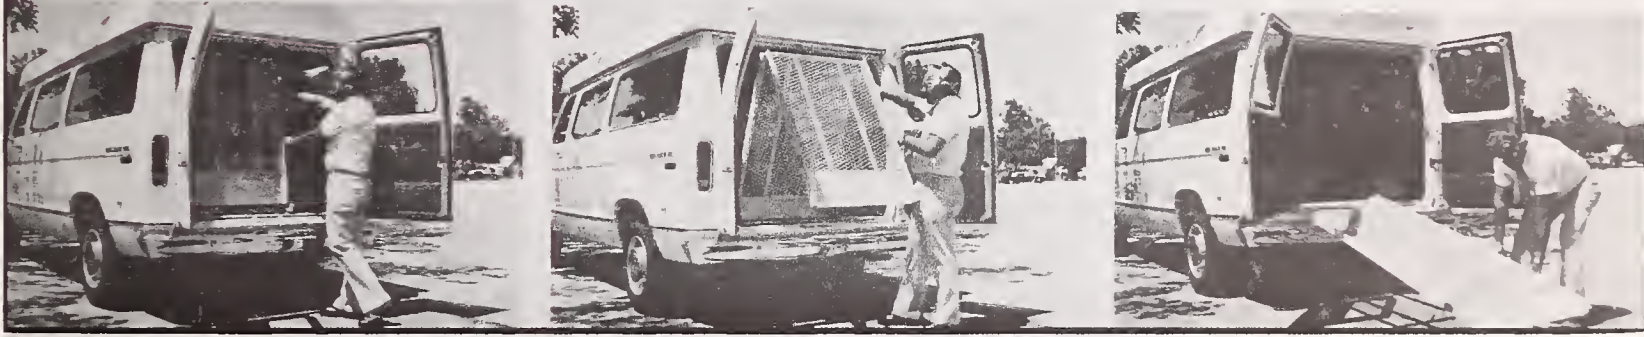
FIGURE 3-3. REAR MOUNTED WHEELCHAIR RAMP

Lifts and Ramps. Lifts or ramps are often installed in paratransit vans as an aid to wheelchair users and others who have difficulty negotiating the step into the van. Figure 3-3 shows one

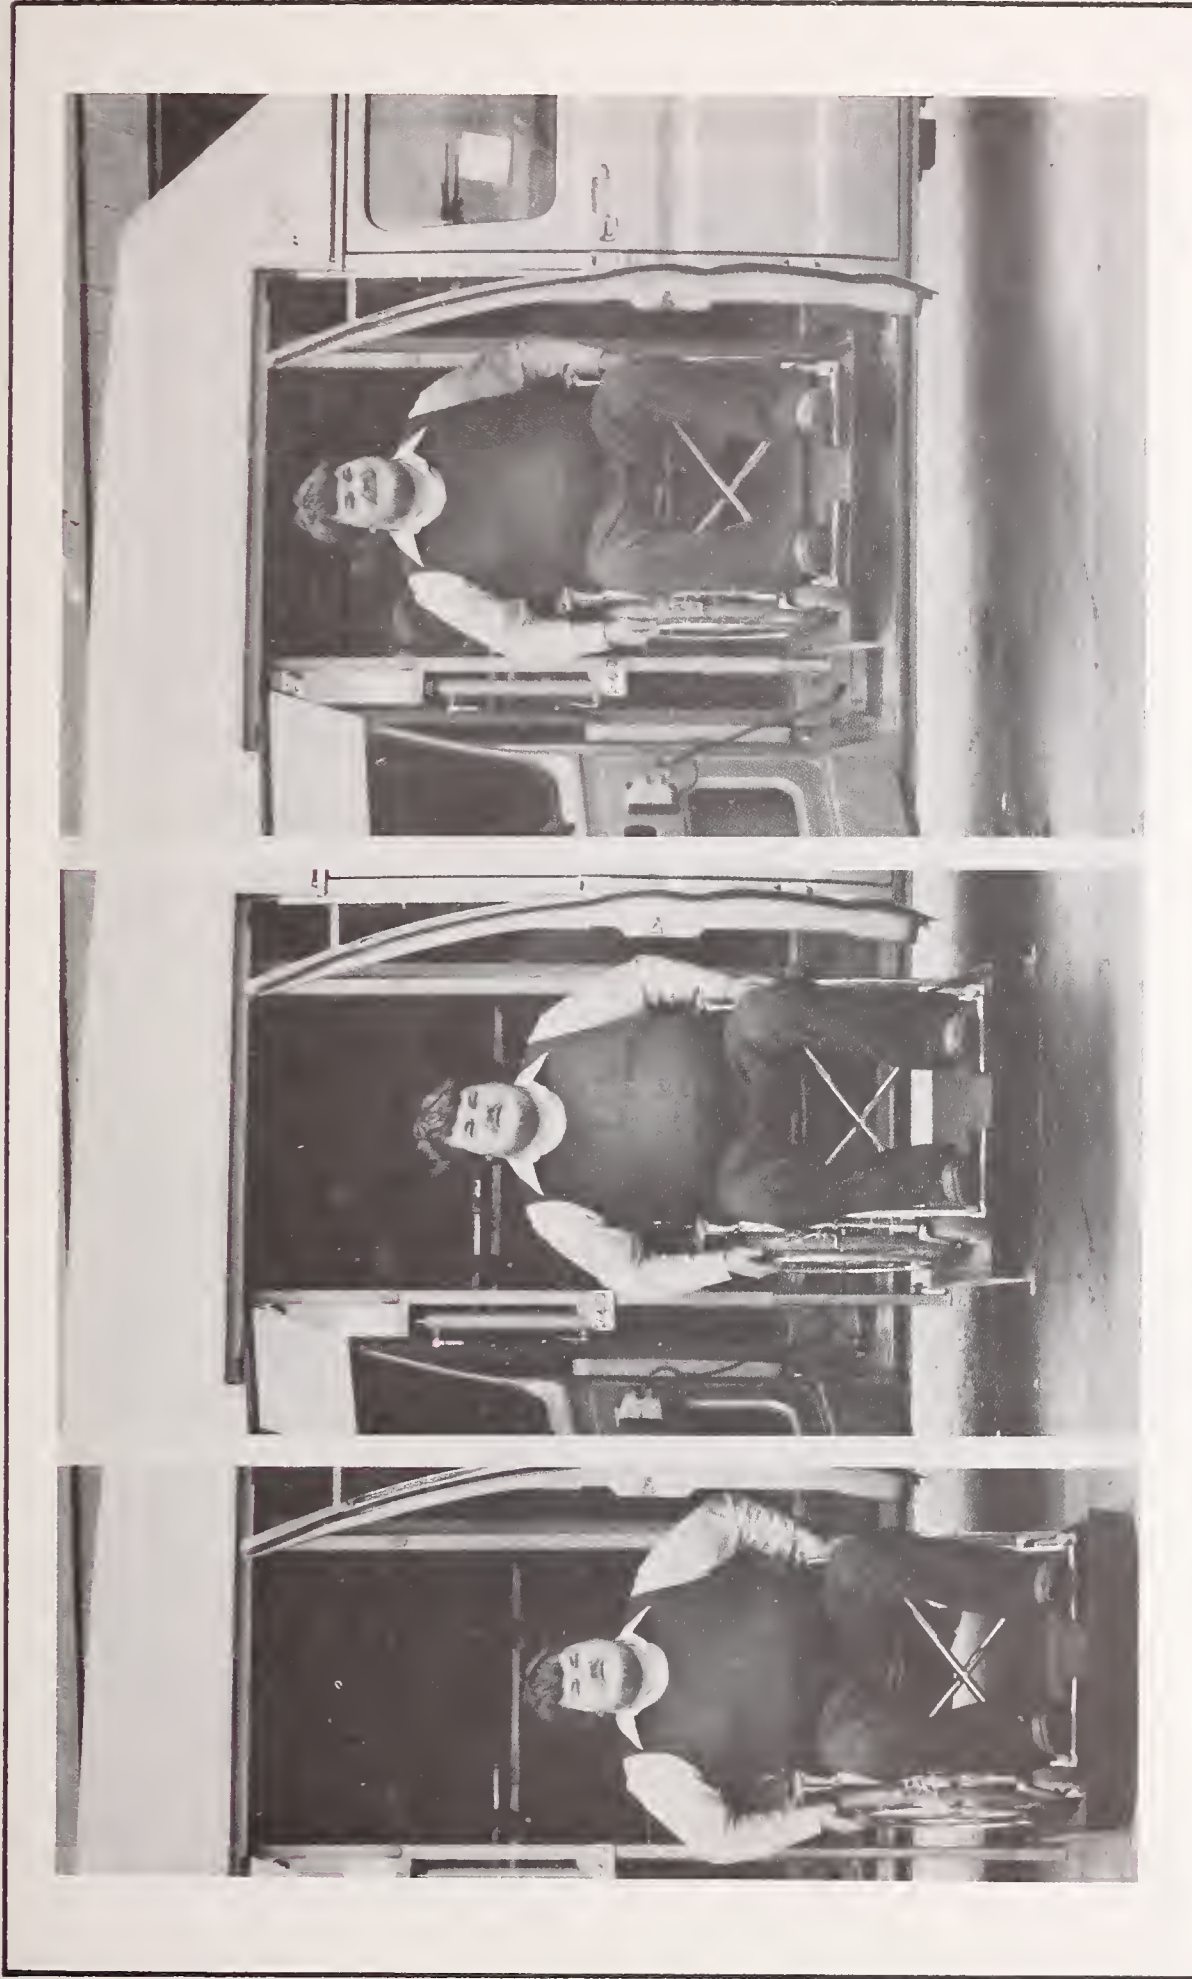
FIGURE 3-4. POWERED WHEELCHAIR LIFT INSTALLED IN MODIFIED VAN

Figure 3-4 shows a powered lift installed in a modified van and being operated by a wheelchair user. Figure 3-5 shows a lift in its stored position in a van. This typical lift fully blocks the side door while stored and may become inoperative in an accident. Rescue personnel would have to use the rear or cab doors or to cut through the side of the van to gain access. In contrast, another type of side-mounted lift (Figure 3-6) folds in half when stored, thus allowing some access by rescue personnel.

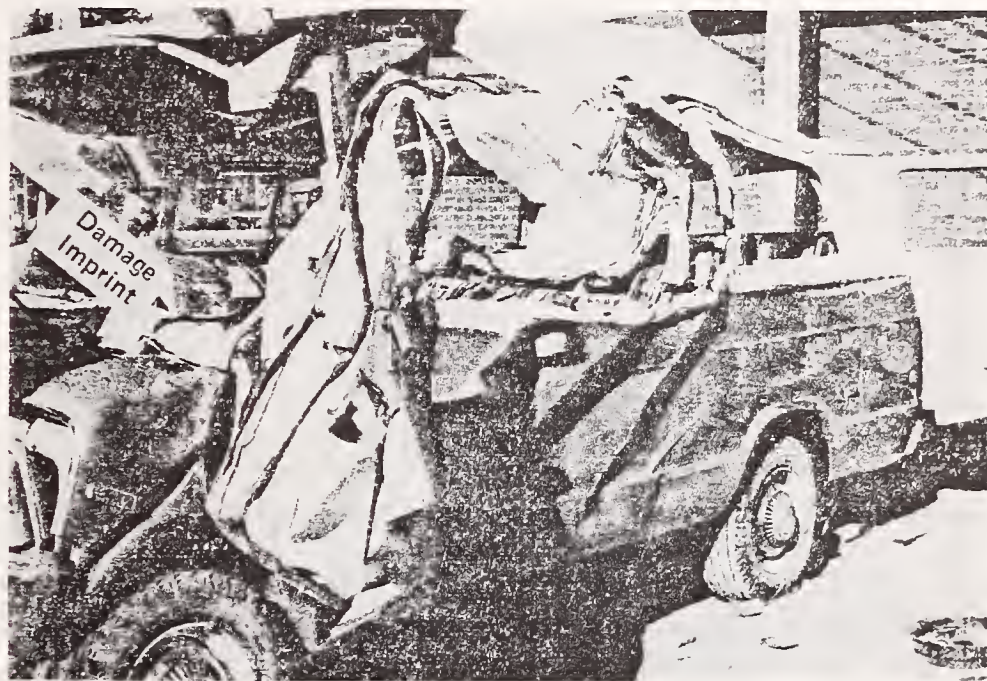
Note damage imprint from bridge parapet at top of left front fender and at top of left side instrument panel. Note buckling of side panel to rear tire area.

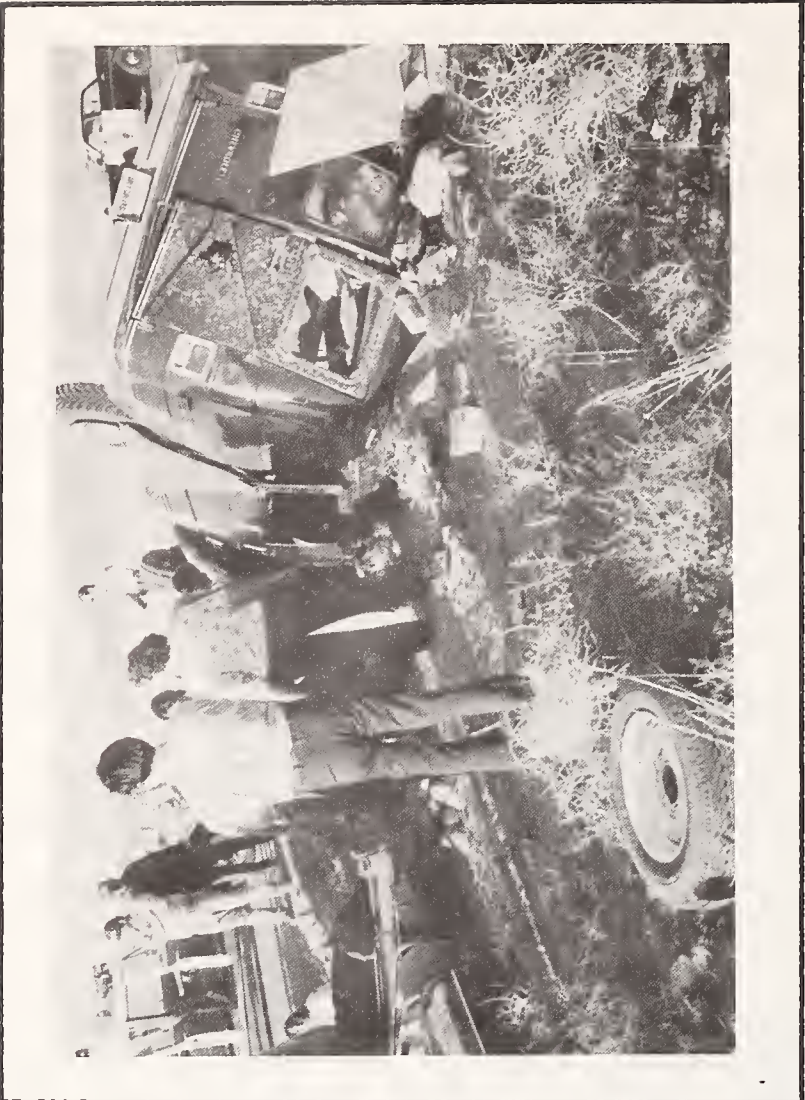
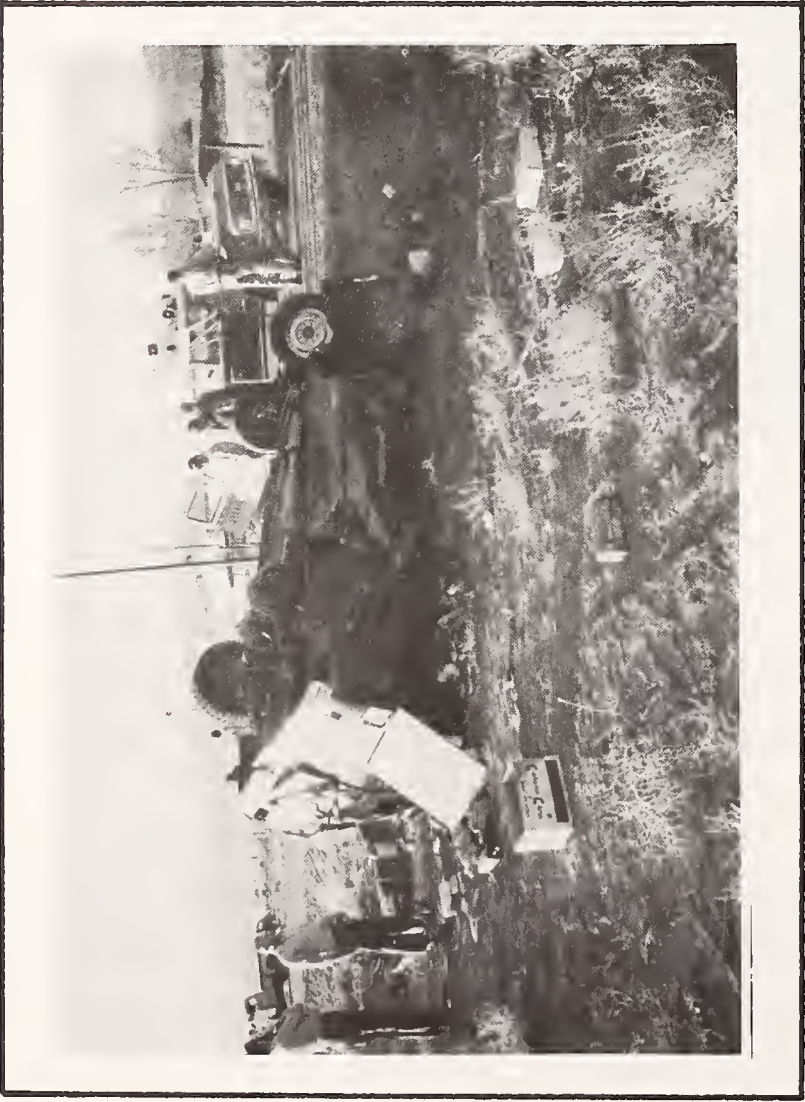
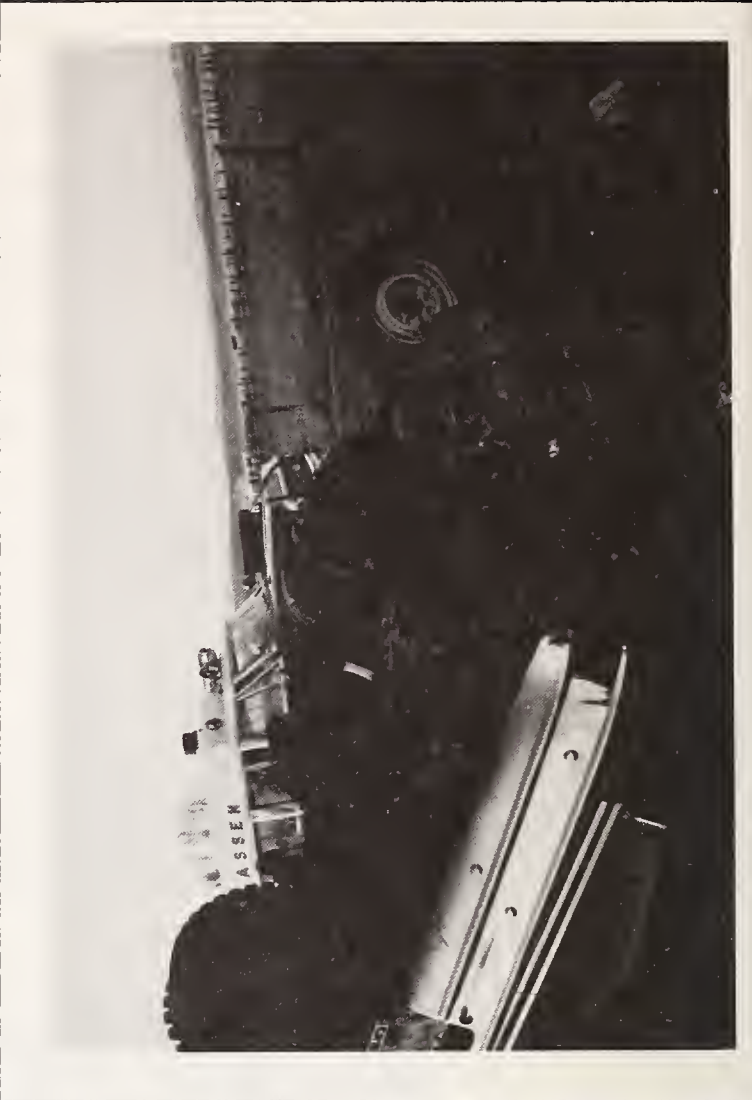
FIGURE 3-11. SUSANVILLE, CALIFORNIA, ACCIDENT:
VAN IN FINAL RESTING POSITION
AT ACCIDENT SITE

Figure 3-11 shows the van in its final resting position. Being upside down made gaining access to the victims extremely difficult, as did the crushing of the roof and the distortion of the body.

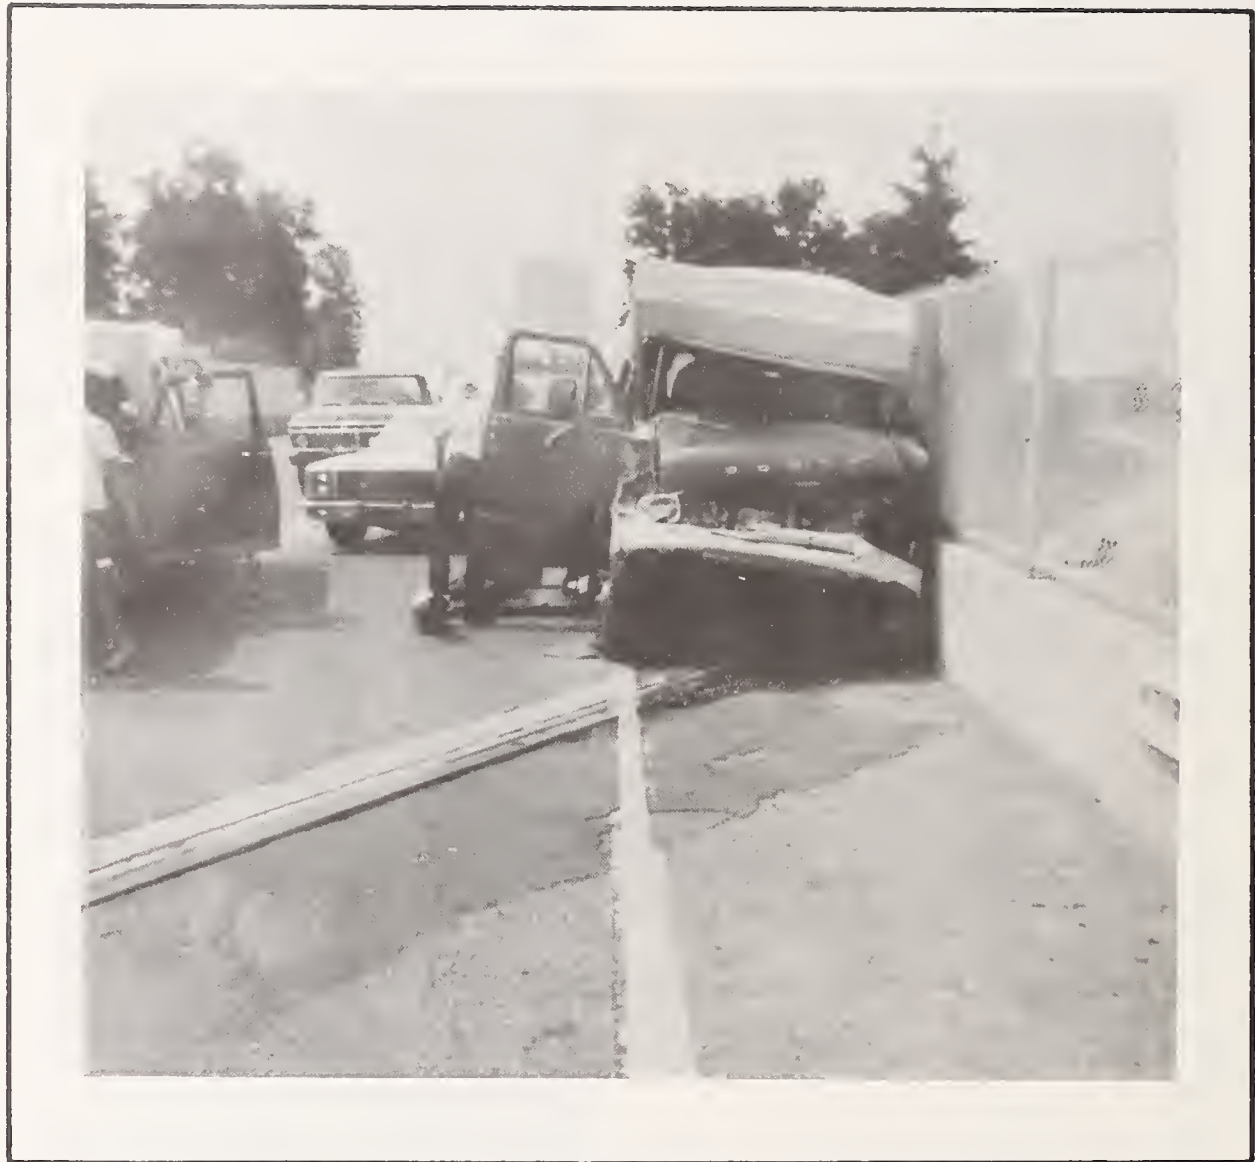
FIGURE 3-12. PARATRANSIT VAN IN FINAL RESTING POSITION AFTER MULTIPLE VEHICLE COLLISIONS: HOWARD COUNTY, MARYLAND

Despite the four collisions, the van remained nearly intact. Figure 3-12 shows the front of the van crushed considerably, but the raised roof stayed in position and the wheelchair lift at the side doors remained operable (Figure 3-13). Figure 4-14 shows emergency first aid being provided to one of the six persons (aged 68, 74, 80+, 84, and 89) on board. It appears from Figure 3-14 that one of the passenger bench seats partially failed as a result of the collisions. Evacuation of the passengers was facilitated by using the side doors and by lowering the wheelchair lift.

carrying a large lighted traffic control arrow, causing it to leave the roadway, and finally with a bridge parapet (Figure 3-12).

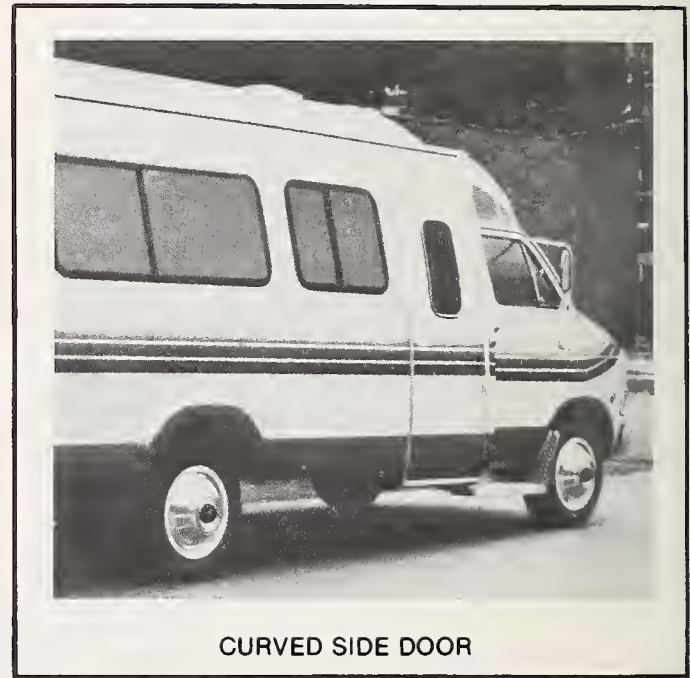
FIGURE 4-2. TYPICAL BODY-ON-CHASSIS SMALL BUS DOOR CONFIGURATIONS

Passenger doors come in a great variety of forms, depending on their location and the degree of modification of the basic vehicle. Three different sorts of door for the same body-on-chassis small bus are shown in Figure 4-2. Other common types include a manually operated extended cab door, similar to those used in modified vans, and dual-leaf folding doors operated manually or electrically. For vehicles equipped with a lift for handicapped passengers, a separate entryway is often provided, either directly behind the passenger door or at the rear right of the bus. If an active lift is installed, the opening is generally obstructed from the inside by the lift platform, as shown in Figure 4-3. The door must, therefore, be opened from the outside before the platform can be lowered and the entryway used. The clear height of such doorways varies from 50" to 70" and depends on the extent to which the bus has been structurally modified and on the characteristics of the lift. Also, depending upon the specific lift installation, the width of the clear opening varies but typically is about 50".

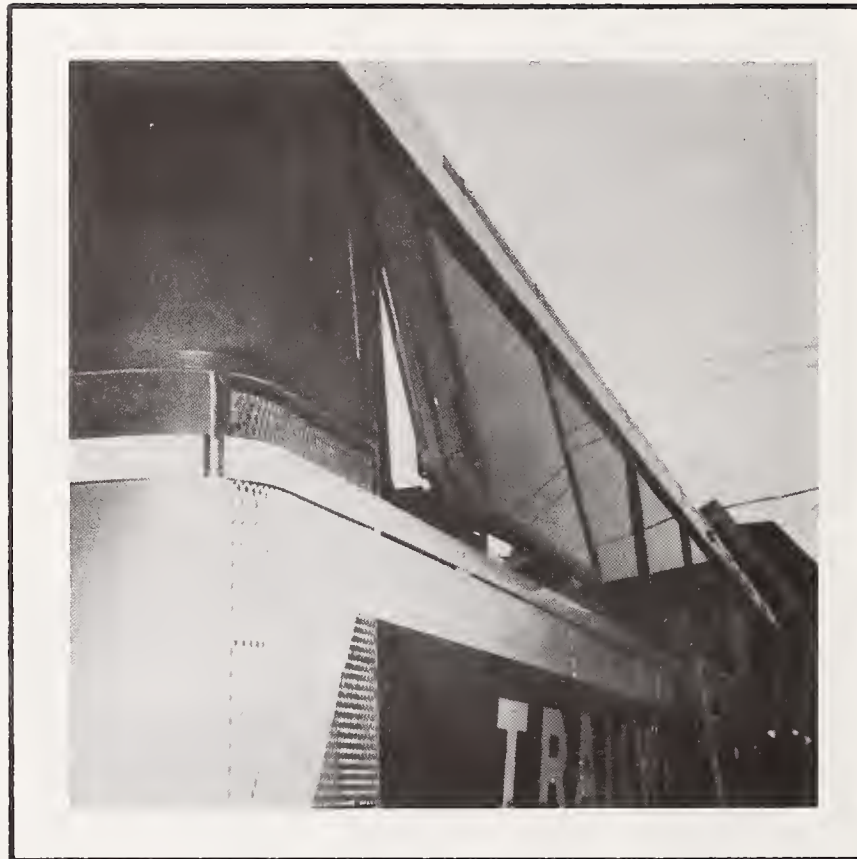
FIGURE 4-10. OUTSIDE DEVICE FOR OPENING DOOR LOCATED UNDER THE "I" IN MCI

Accidents involving these buses are considerably rarer than those involving automobiles. Emergency forces, consequently, do not acquire much on-the-job training that might aid them in future accidents. Nevertheless, the design of these buses should facilitate emergency response. The MCI Intercity Motor Coach may serve as an example. As shown in Figure 4-8, an emergency cutoff switch for the battery is located in an easily opened compartment on the side adjacent to the front door. If the vehicle has been involved in an accident and the engine is still operating, emergency forces can shut it down by using the switch or by cutting the cables. If the compartment is inaccessible as a result of the accident, the engine can be shut down by a switch on the left wall within the engine compartment, as shown in Figure 4-9. If this compartment also is inaccessible, the engine can be shut down by a switch on the dashboard at the operator's position. This assumes easy access to the interior, but as one can see in Figure 4-10, the door does not have a handle. If one looks closely at this figure, however, one can see that there is a mechanical device on the front of the bus, directly below the "I" in MCI, for operating the door.

Instructions for opening the doors should be placed on the outside of vehicles. Figure 4-10 shows an outside door opener that is not indicated in any way. The lack of indication is, of course, intentional, but some compromise between the safety of passengers and the security of the bus must be reached.

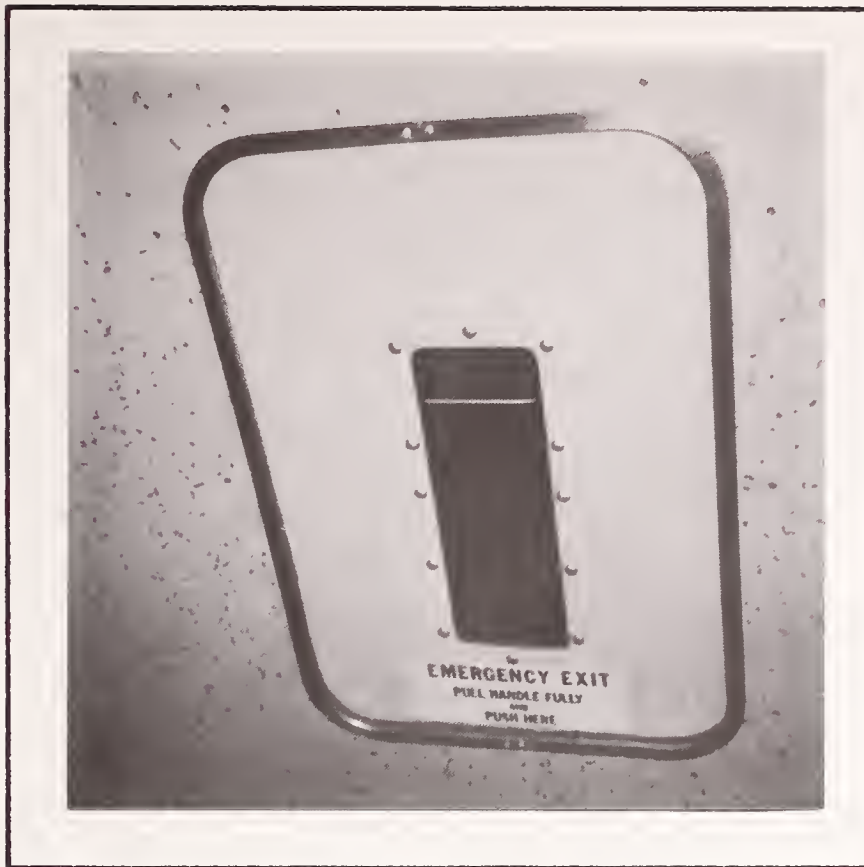
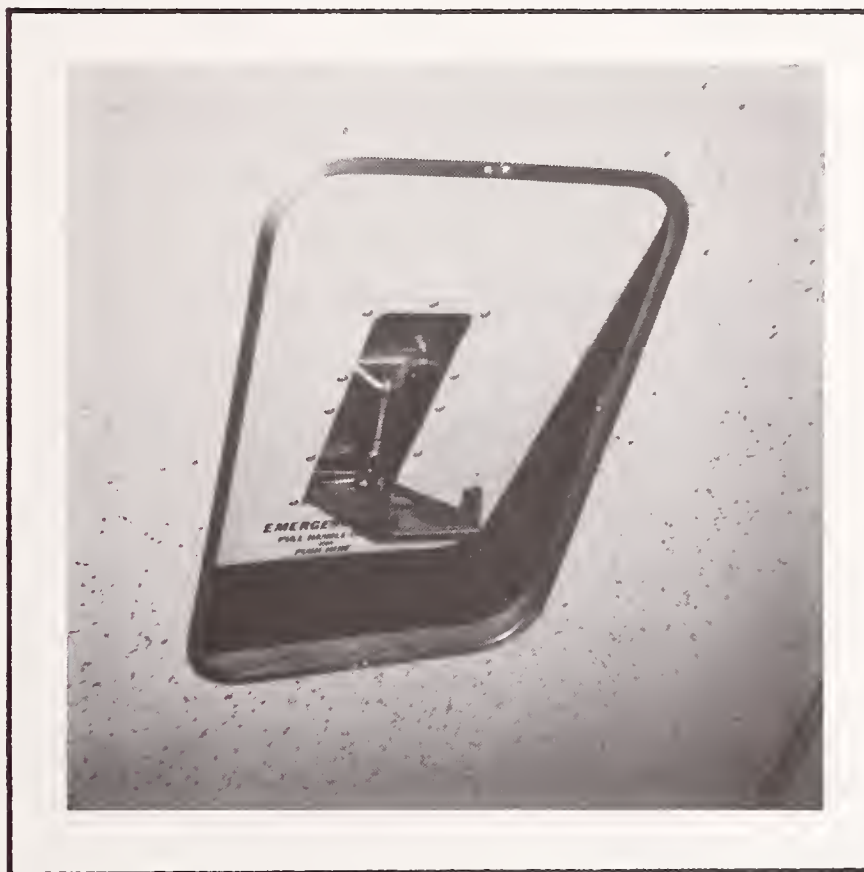
FIGURE 4-11. HINGED EMERGENCY ESCAPE WINDOW ON MCI INTERCITY BUS

FIGURE 4-12. CLOSED AND OPEN EMERGENCY HATCHES IN ROOF OF MCI INTERCITY BUS

There are three escape routes from the vehicle in addition to the main door. They are: the side windows, each of which is hinged as shown in Figure 4-11; the windshields, which are removable when the rubber inserts are pulled out; and two emergency escape hatches in the roof. A closed hatch and a partially open one are shown in Figure 4-12. The hatches are actuated by a simple pull-push quick release mechanism and can easily accommodate someone standing 6 feet tall and weighing 240 pounds, as can be attested to by the author who easily negotiated one of these hatches.

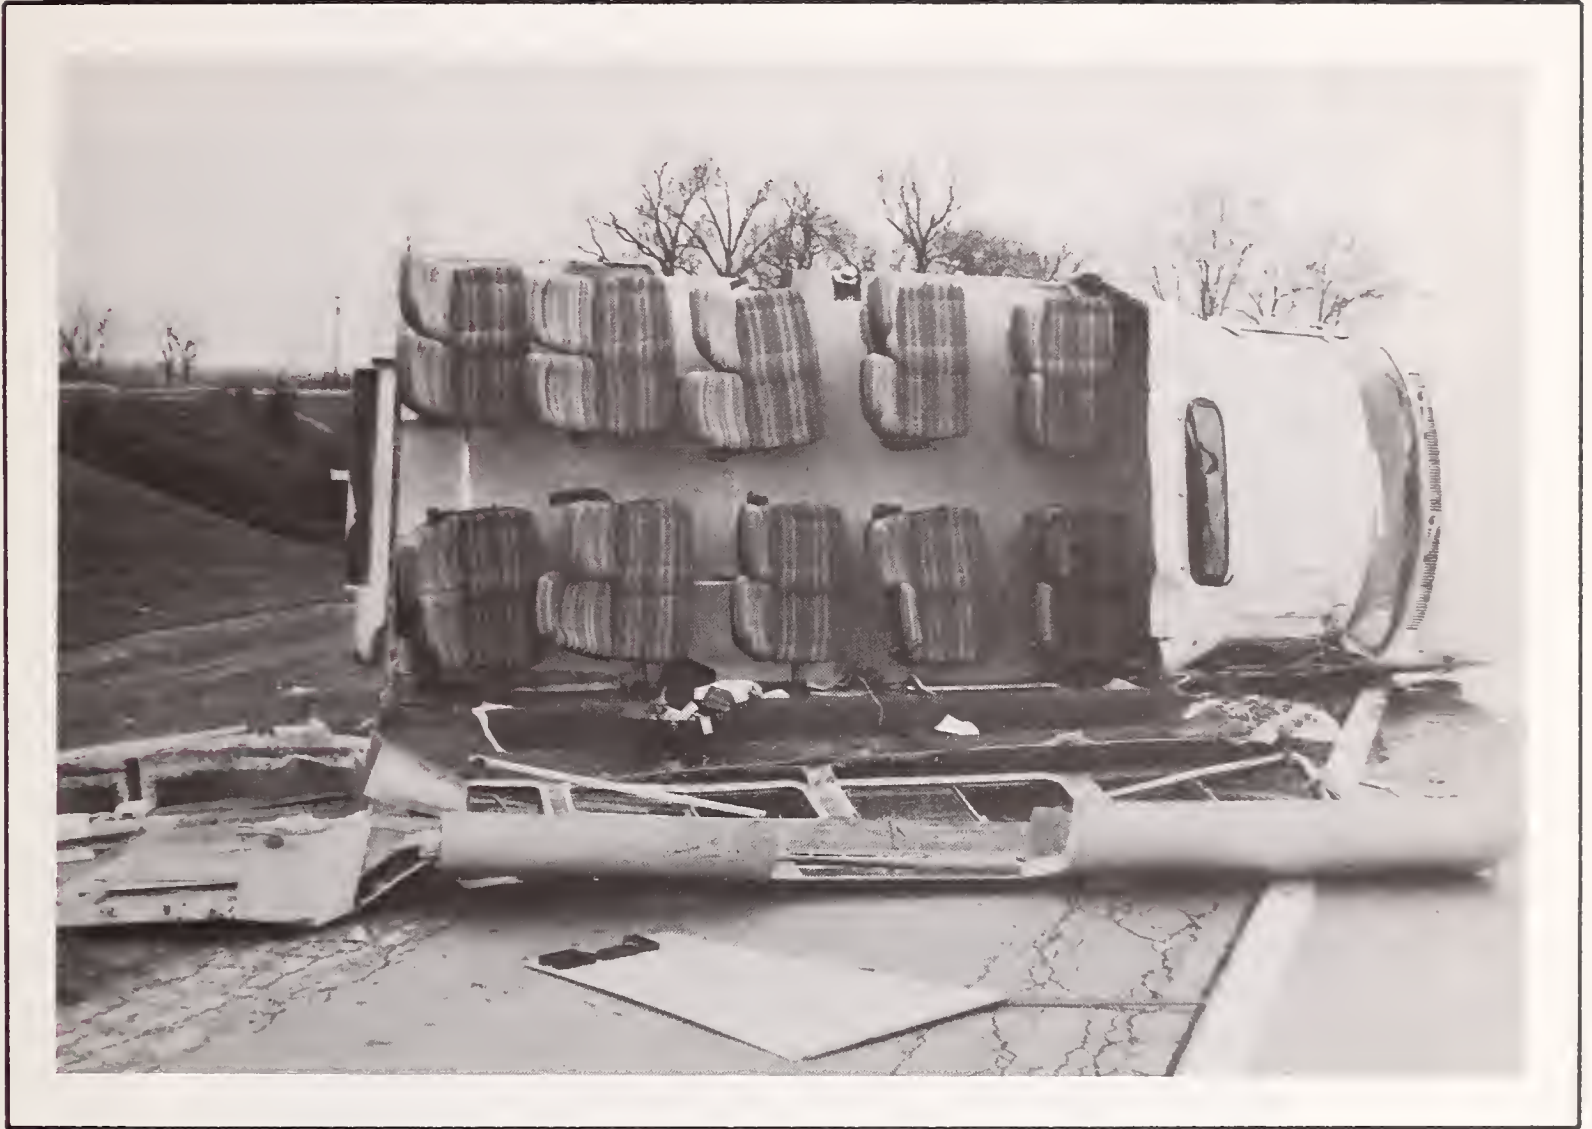
FIGURE 4-13. BODY-ON-CHASSIS SMALL BUS ACCIDENT: SCOTT COUNTY, KENTUCKY

Figure 4-13 shows the bus in its final resting position on its side. Note that the left side wall of the body became detached at the floor line, allowing the side wall and the roof to peel off and unfold onto the pavement. The rear portion of the body also appears to have come away at the floor level and is resting on the shoulder of the roadway. Figure 4-14 shows a front view of the vehicle. It appears that the Ford cab and chassis functioned quite well and demonstrated adequate crashworthiness. Rescue forces experienced little difficulty in gaining access to the victims.

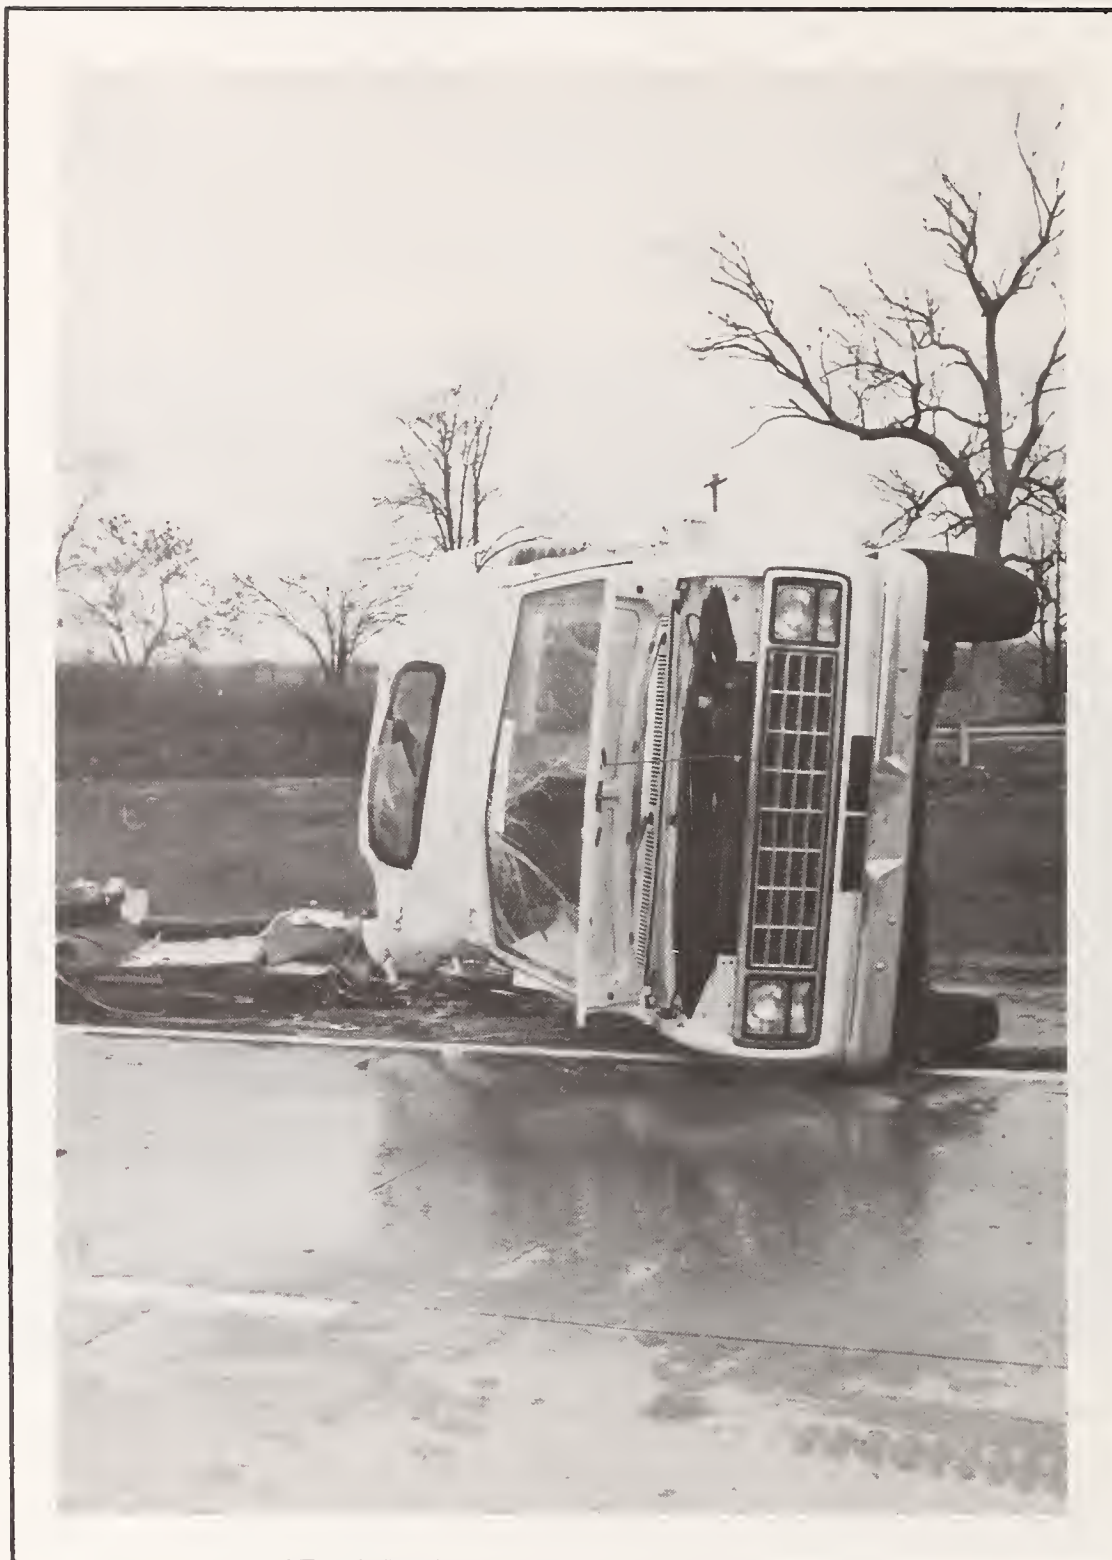
FIGURE 4-14. BODY-ON-CHASSIS SMALL BUS ACCIDENT: SCOTT COUNTY, KENTUCKY

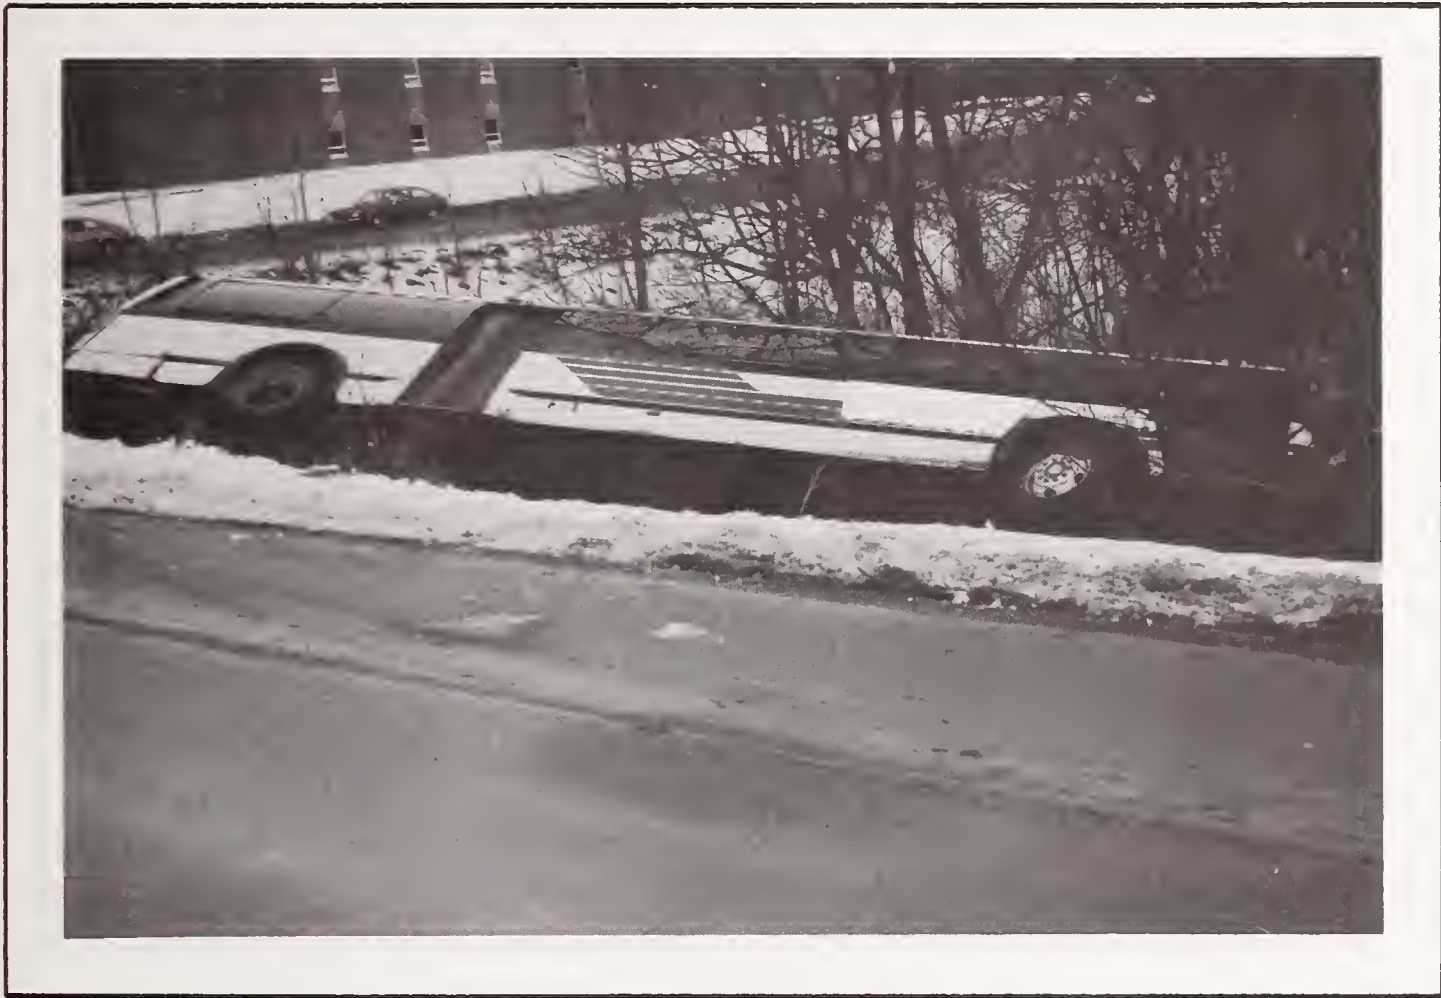
FIGURE 4-15. URBAN TRANSIT BUS ACCIDENT IN MIDWESTERN CITY

Figure 4-15 shows the bus at rest. Note that the front door was still operable and was used in the rescue. Also note, in Figure 4-16, that the last side window on the right side and one of the middle windows are ajar and were presumably used by the passengers or rescuers. It is not known if the escape hatches in the roof were used. Of the 29 passengers on board, 17 were shown in the police report to have had "probable-not apparent" injuries. The passengers ranged in age from 20 to 62.

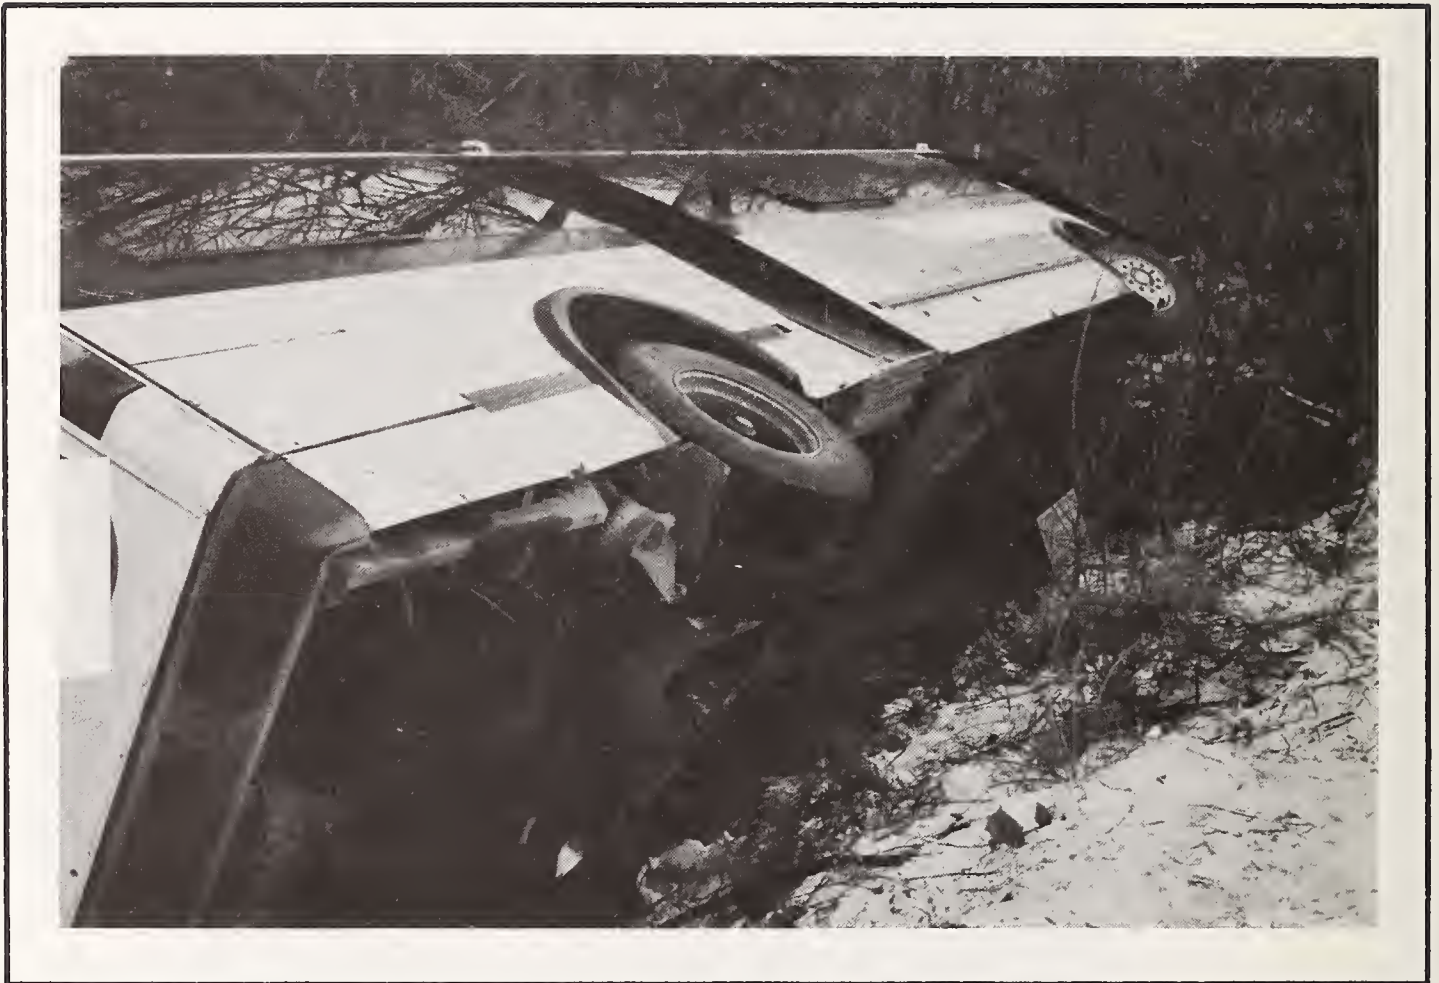
FIGURE 4-16. URBAN TRANSIT BUS ACCIDENT IN MIDWESTERN CITY

Emergency Forces. Emergency forces need devices to keep open those windows that function as emergency exits while emergency medical personnel and supplies enter the bus and injured passengers, some on backboards, are removed. Some sort of expandable pole can be used and needs to be made available at low cost to emergency forces. Rescuers also need a short ladder to reach the windows from the ground if the bus is upright or to reach the side of an overturned bus like the one shown in Figure 4-16. It must be decided whether such ladders should be carried on the vehicle during revenue service.

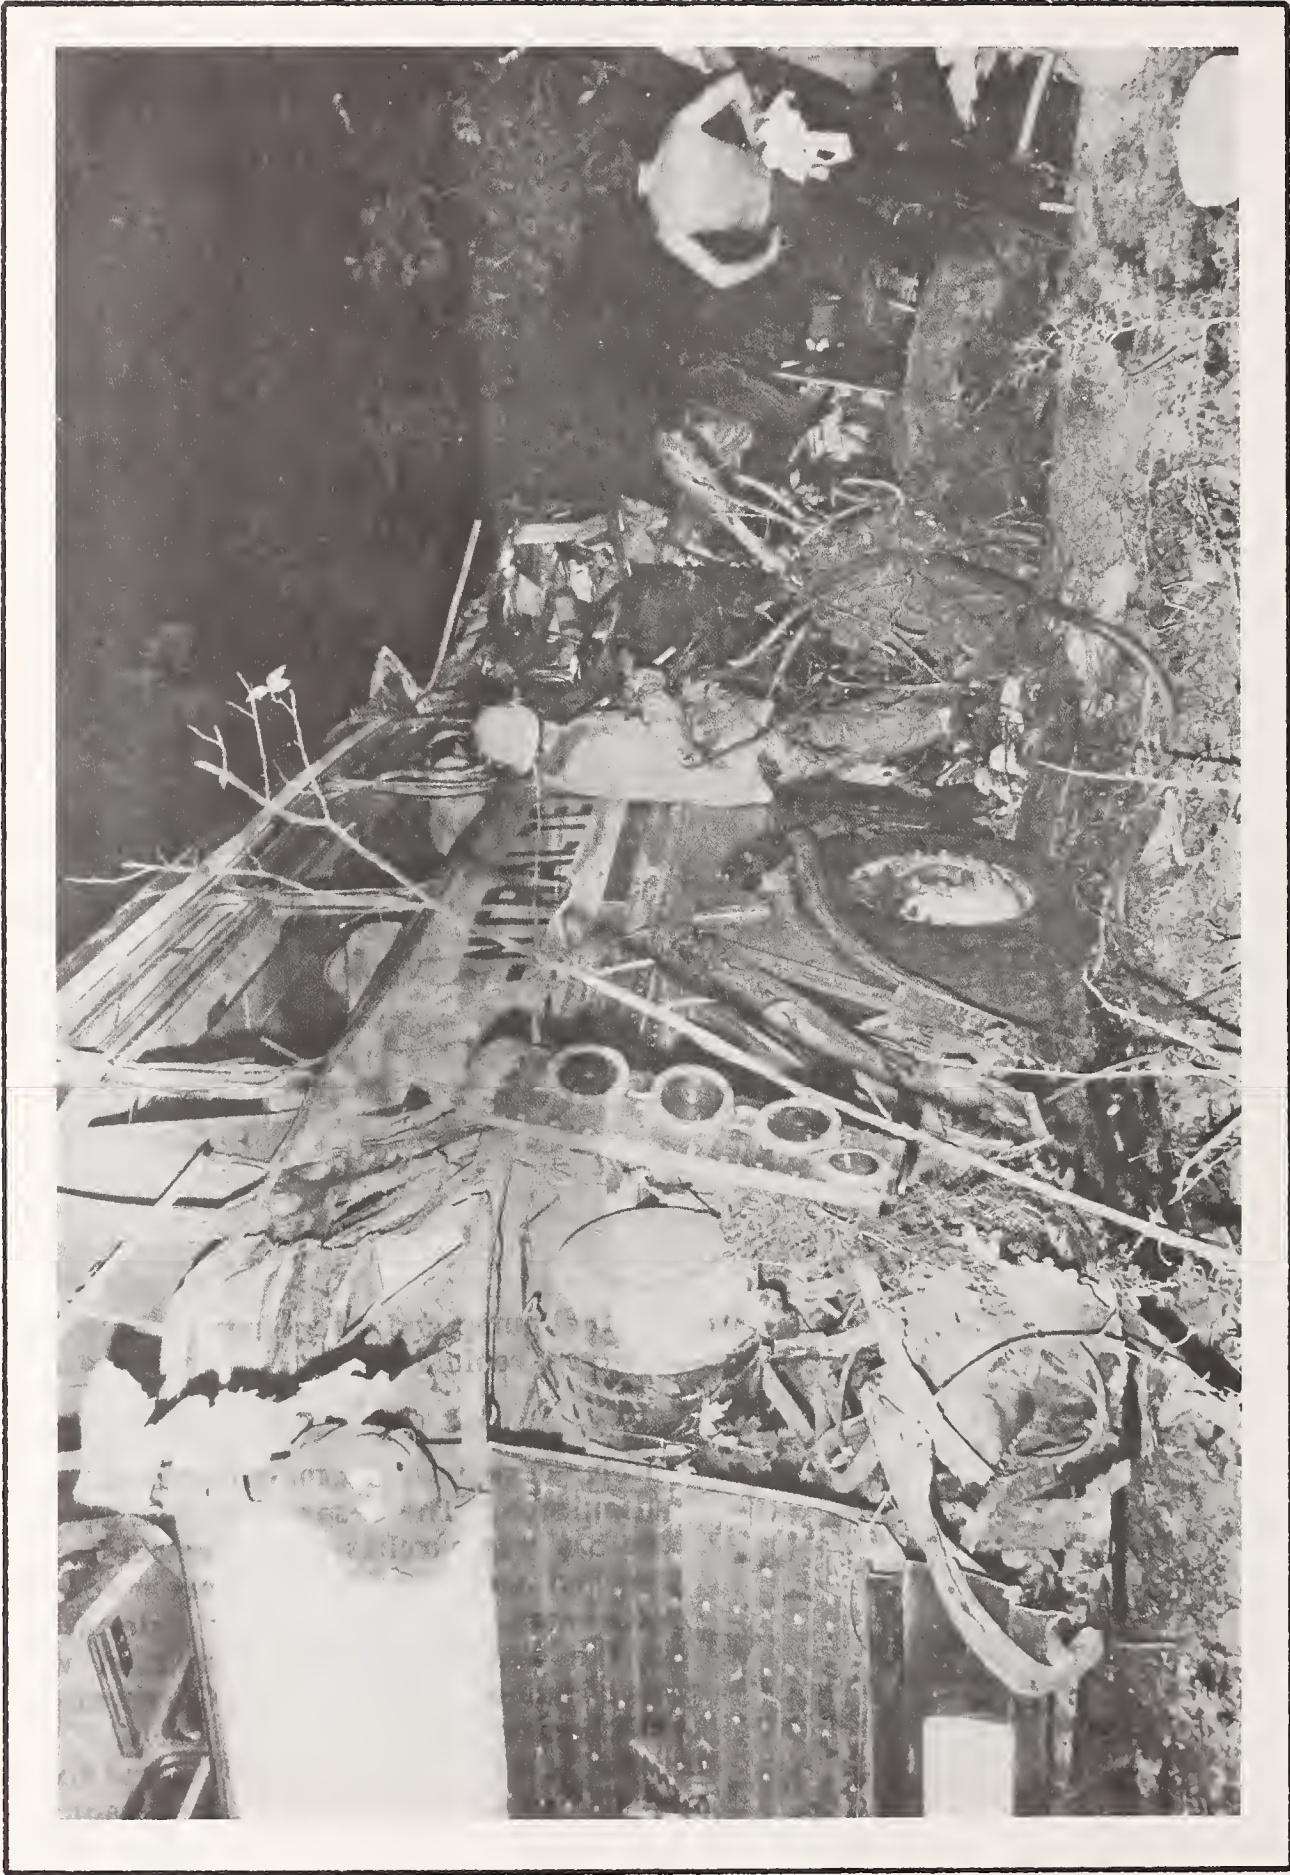
FIGURE 4-20. JASPER, ARKANSAS, INTERCITY MOTOR COACH BUS ACCIDENT:
FINAL RESTING POSITION

The driver and two passengers were ejected when the bus struck the berm. Two more passengers were ejected when the bus went down the embankment, and several were ejected when the bus came to rest against the rock (Figure 4-20).
